# LOWER DUWAMISH WATERWAY SLIP 4 EARLY ACTION AREA

## LONG-TERM MONITORING DATA REPORT YEAR 1 (2013)

January 27, 2014

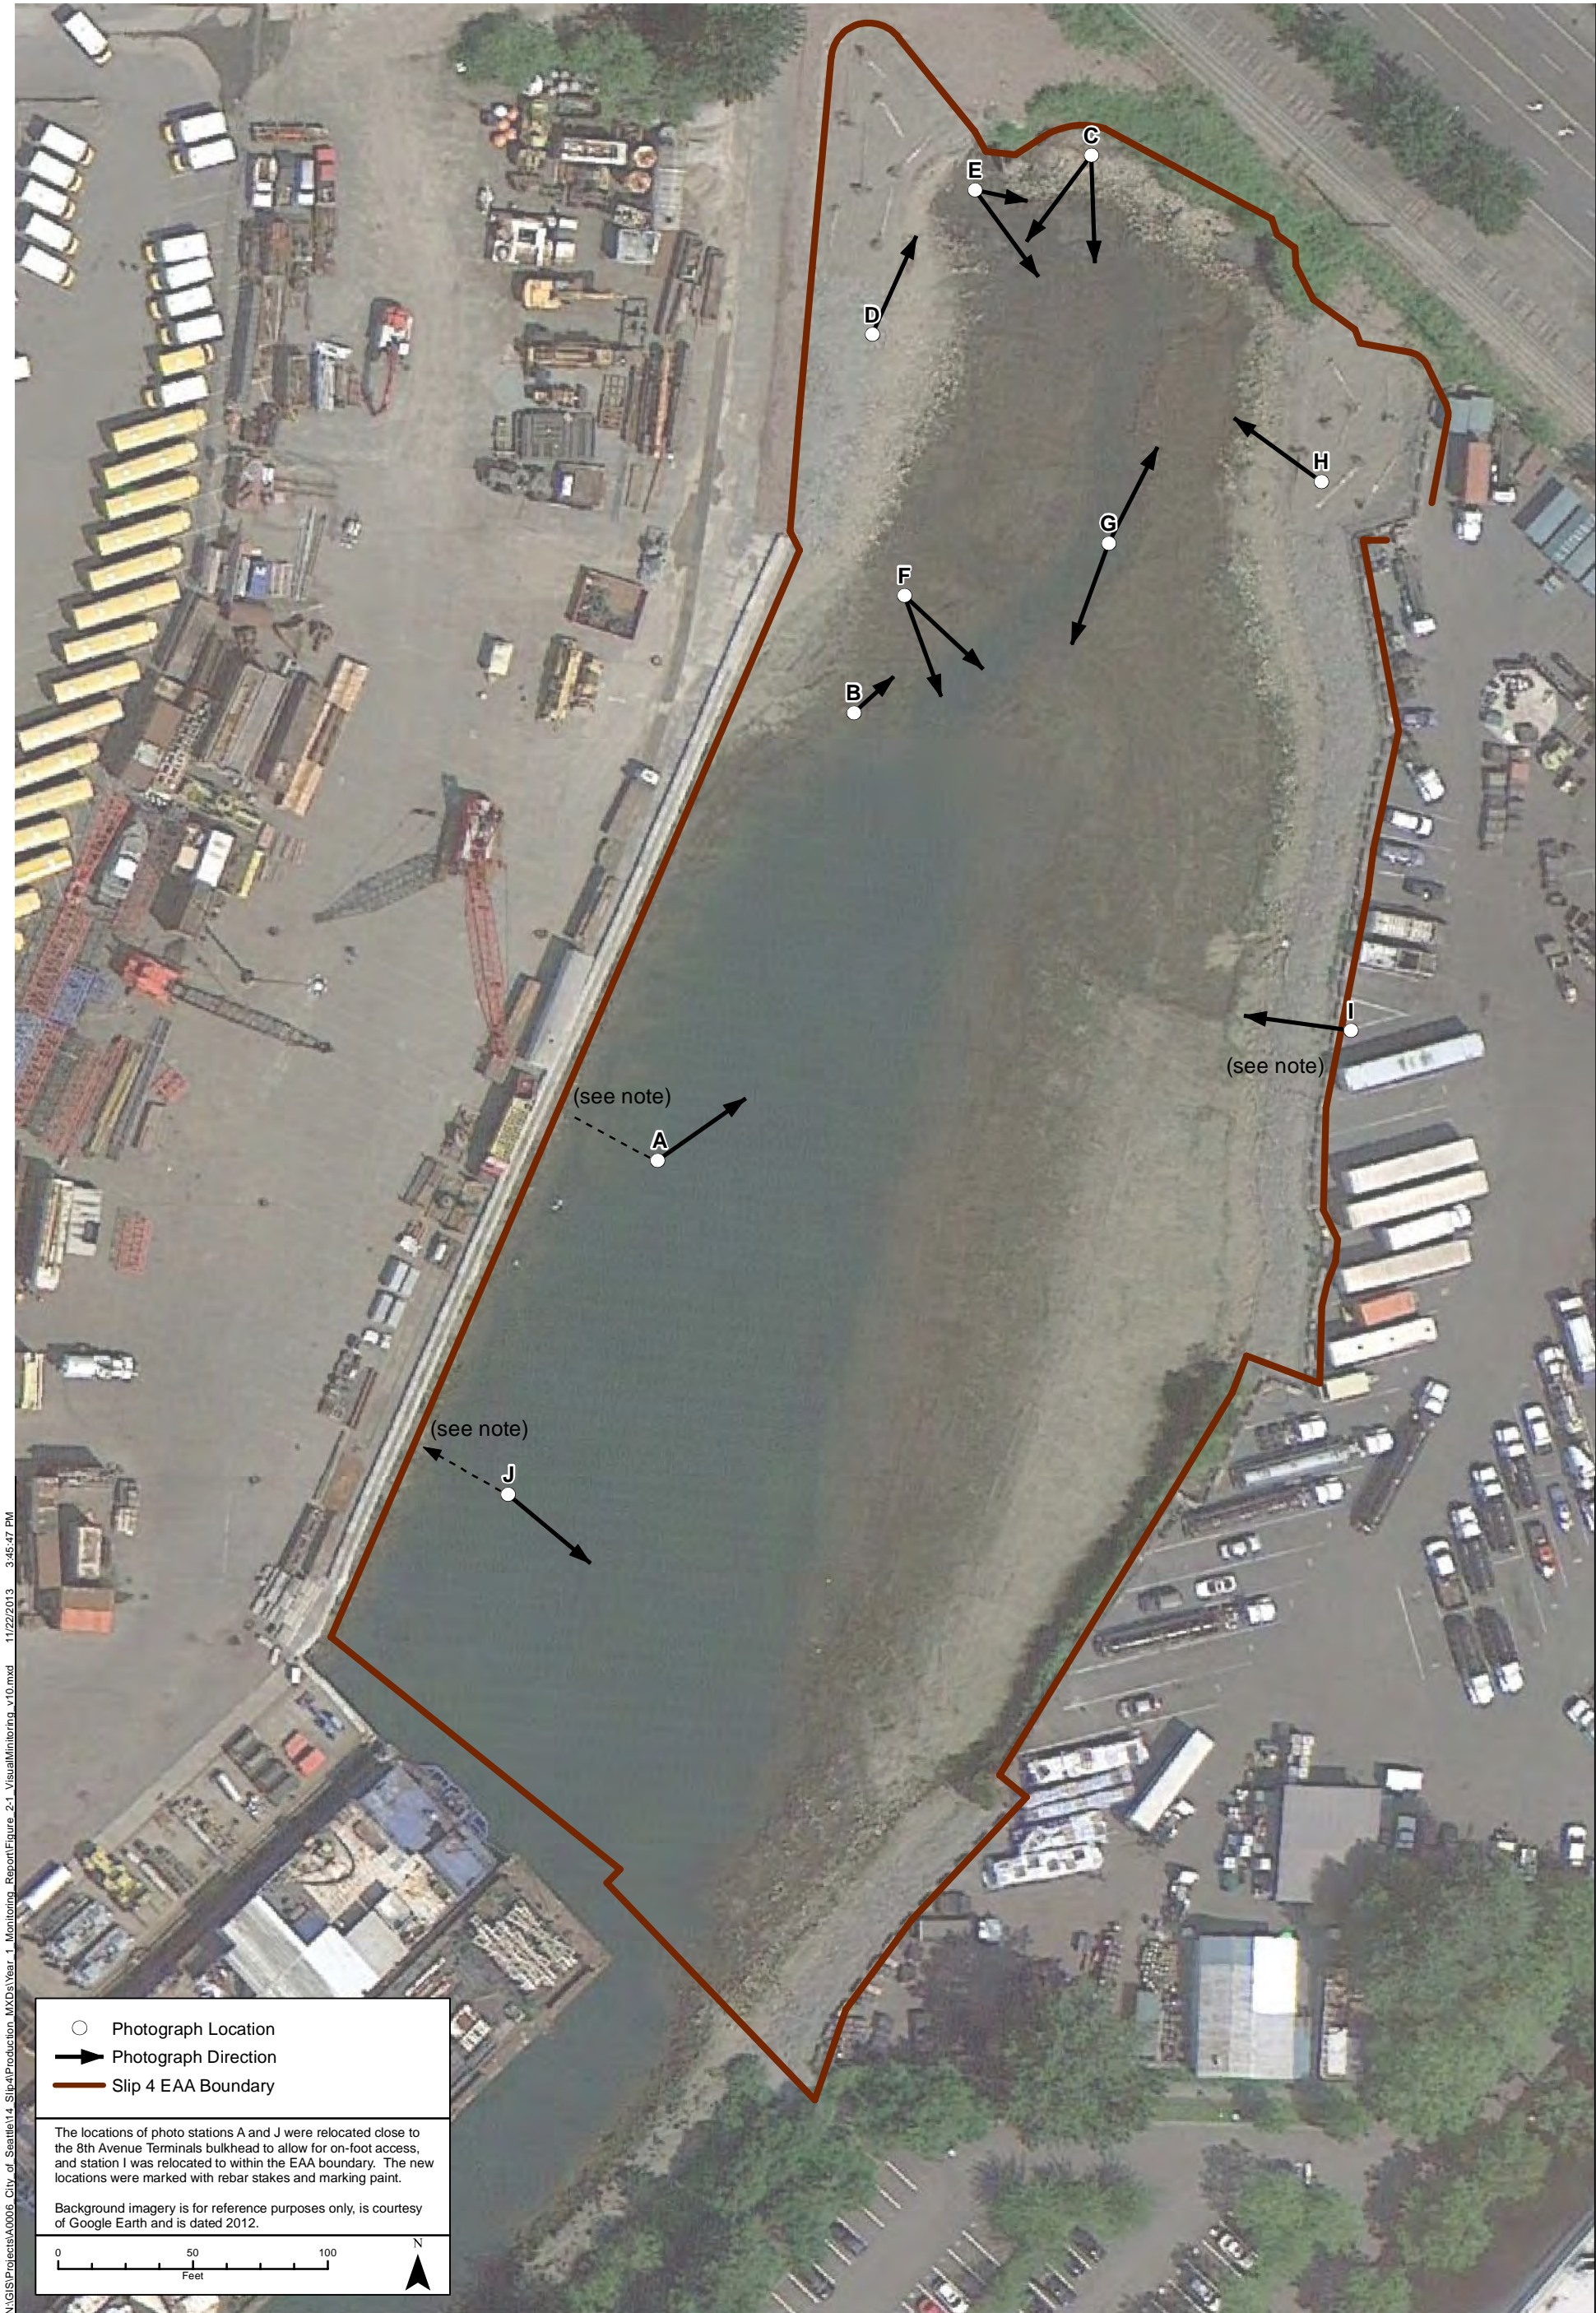
**Figure 2-1.**  
 Visual Monitoring Station Locations  
 Slip 4 Early Action Area  
 Long-Term Monitoring Data Report - Year 1 (2013)

As noted in Table 2-2 and Figure 2-1, three photo stations were relocated in the field. Stations A and J were identified in the LTMRP as being in what was likely a subtidal area of the slip. Therefore during this first monitoring event, these stations were relocated to the northwest, close to the 8<sup>th</sup> Avenue Terminals property bulkhead, to allow for upland access. Station I was relocated to the west, from the First South Property upland area to within the Slip 4 EAA boundary.

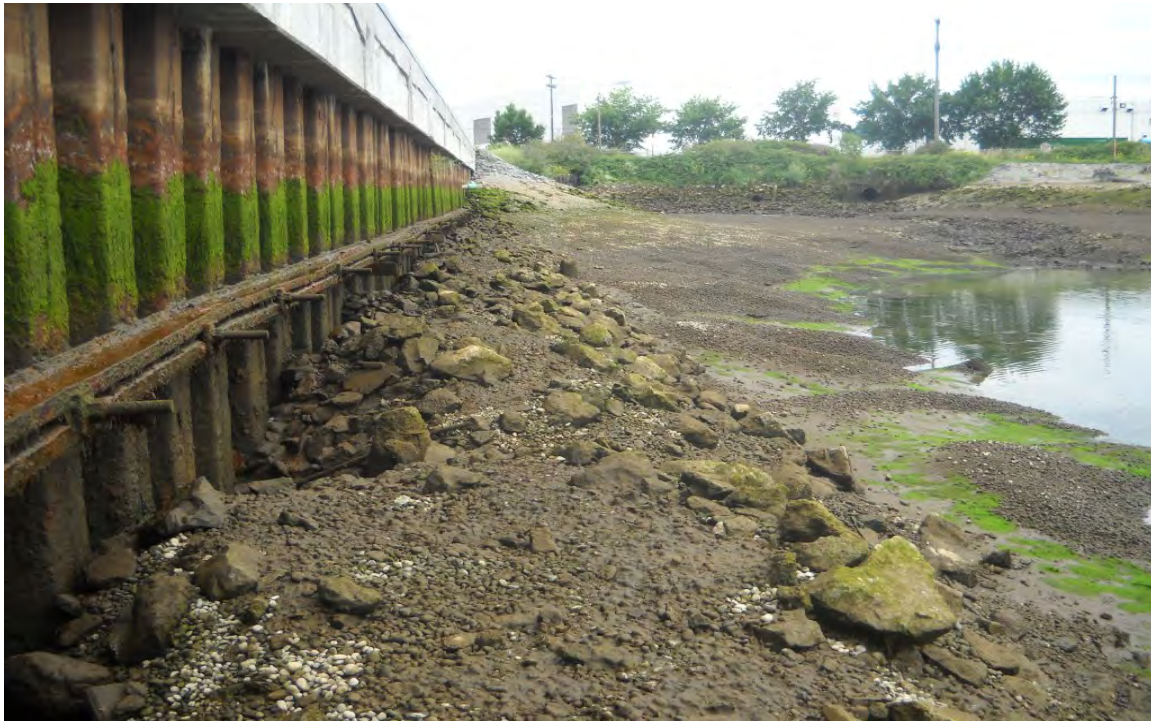
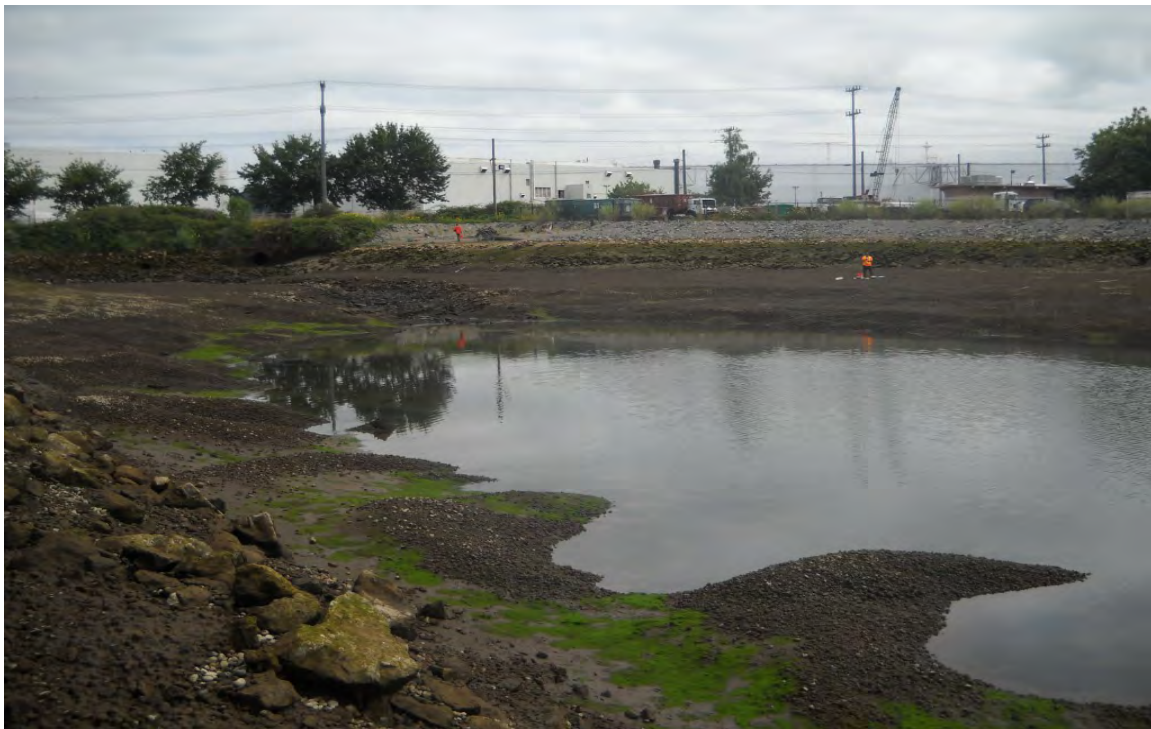
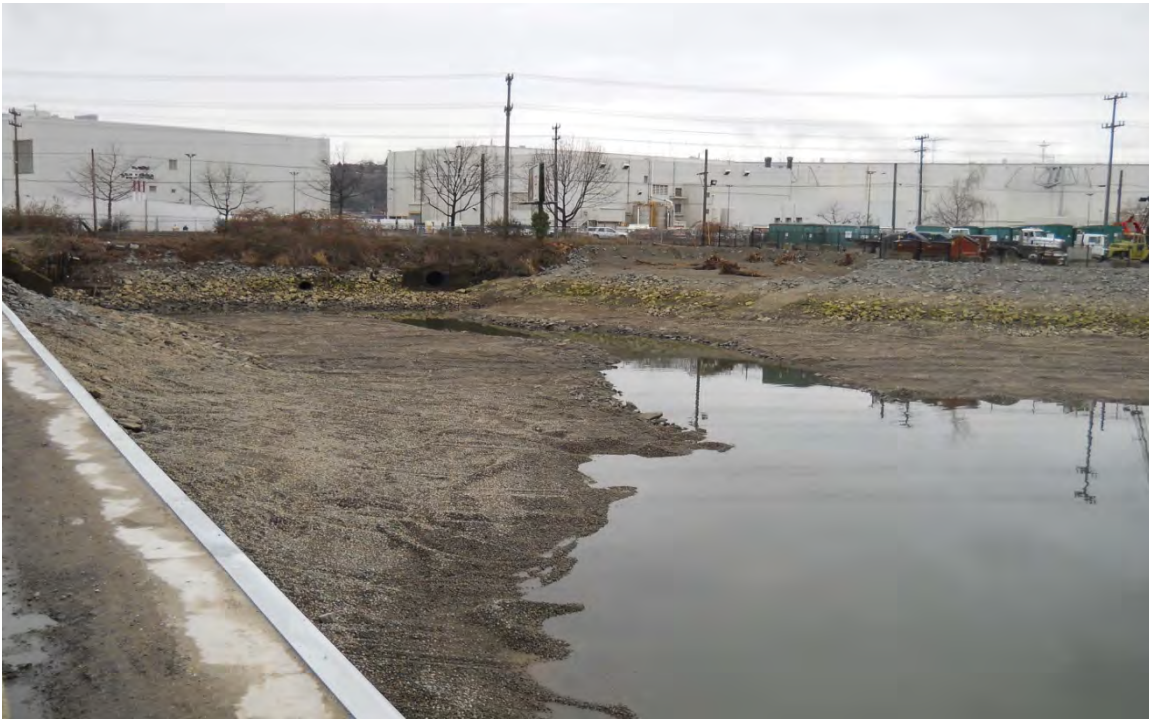
A1\_East Central Sediment Cap\_2013

Area Observed	Photo Station ID <sup>a</sup>	Date	Time	Azimuth	Area Substrate Classification	Color	Estimate Thickness of Fines	Organic Matter	Wildlife Use Observations	Assessment of Cap Integrity
East-Central Sediment Cap	A1	7/22/2013	1115	55 <sup>b</sup> T	Cobble, gravel, sand, silt/clay	Brown	< 1 cm	Trace sticks, fibrous algae, trace leaf litter	Crows feeding on East Sediment Cap, flies	Good
North Sediment Cap	B1	7/22/2013	1103	48 T	Cobble, gravel, sand, silt/clay	Brown surface, gray, brown	< 1 cm on North Sediment Cap	Sticks and twigs on sediment cap, trace leaf litter, same on North Slope Cap	Flies on North Sediment Cap, trace feathers on North Slope Cap	Good
Northwest Slope Cap, South Sediment Cap	C1	7/22/2013	0955	178 T	Cobble, gravel, sand, silt/clay	Brown	< 1 cm on North Sediment Cap	Trace leaves, large and small sticks (largest ~ 10 ft long by 0.5 ft diameter on Slope Cap)	None on Slope Cap observed; flies observed on Sediment Cap	Good

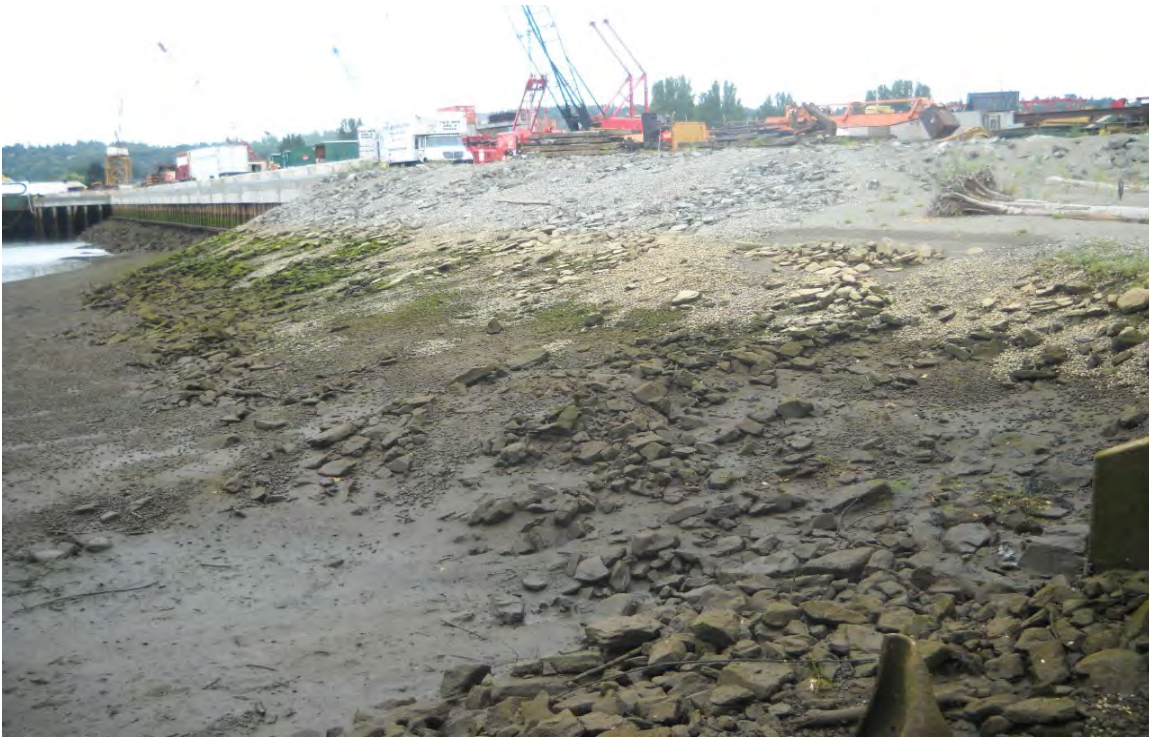
C2\_Northwest Slope Cap - Azimuth 217T\_2013

Northwest Slope Cap	C2	7/22/2013	1000	217 T	Cobble, gravel, and sand	Brown and gray	< 1 cm	Log and sticks	None	Same as above
Northwest Beach/Anchored Logs	D1	7/22/2013	1025	24 T	Cobble and sand	Brown and gray	None	Sticks, feathers, log, bird droppings	None observed	Good
North Slope Cap, Outfalls	E1	7/22/2013	1015	102 T	See classification for Station B above	See color for Station B above	None	Sticks and twigs on sediment cap, trace leaf litter, same on North Slope Cap	Trace feathers on North Slope Cap, flies.	Good
Northeast Slope Cap, North Rip Rap Slough	E2	7/22/2013	1020	144 T	Cobble, gravel, sand, silt/clay	Brown surface, gray and brown	< 1 cm on rocks, sand deposits several cm thick in slough	Sticks	None observed	Good
East Slope Cap, East Sediment Cap, Central Rip Rap Slough	F1	7/22/2013	1053	133 T	Cobble, gravel, sand, silt/clay, and organic matter	Brown and gray	< 1 cm	Sticks, algae at high water line	None observed	Good

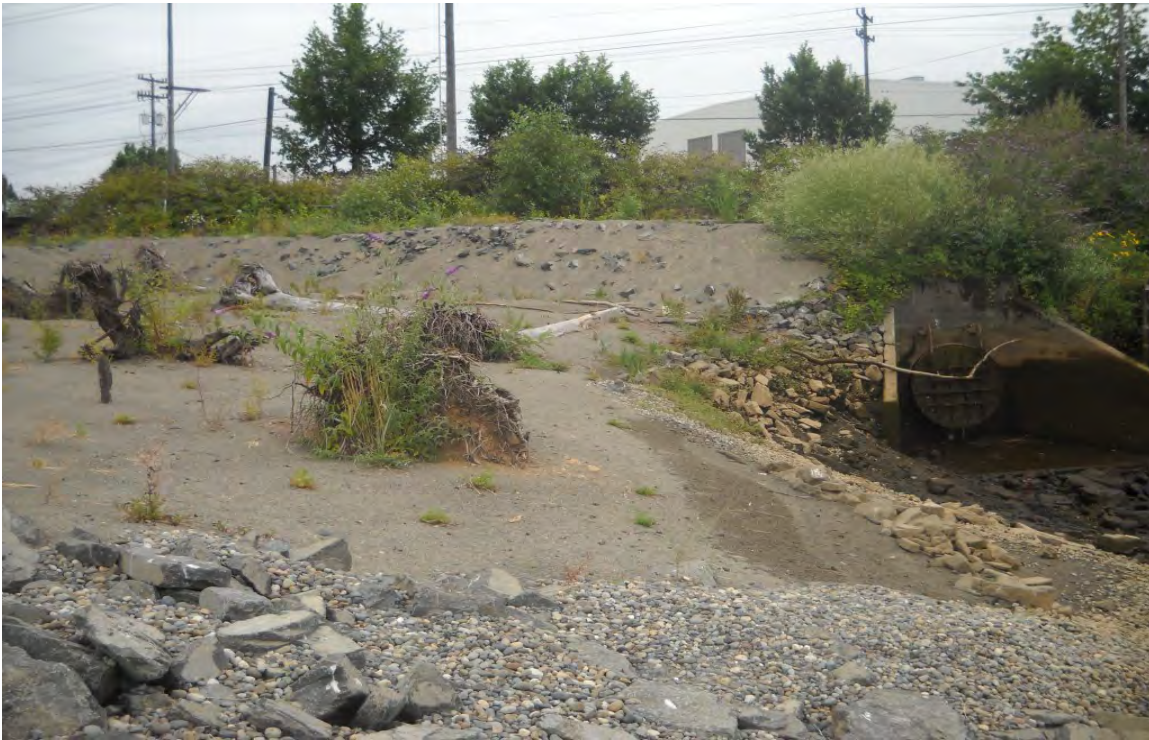
D1\_Northwest Beach/Anchored Logs – Azimuth 24 T\_2013

Northwest Beach/Anchored Logs	D1	7/22/2013	1025	24 T	Not applicable	None observed	Minor litter	Photo station marked with new rebar and red paint.
North Slope Cap, Outfalls	E1	7/22/2013	1015	102 T	None observed	None observed	Some plastic detritus near high water mark	Photo station marked with new rebar and red paint.
Northeast Slope Cap, North Rip Rap Slough	E2	7/22/2013	1020	144 T	None observed	None observed	None observed	Same as above.
East Slope Cap, East Sediment Cap, Central Rip Rap Slough	F1	7/22/2013	1053	133 T	Some small barnacles on gravel	None observed	None observed	Photo station marked with new rebar and red paint.
Southeast Slope and Sediment Cap	F2	7/22/2013	1057	160 T	Some small barnacles on gravel	None observed	None observed	Same as above.
South Rip Rap Slough	G1	7/22/2013	1038	200 T	Barnacles on intertidal rocks in slough; shell fragments and live mussels (three at WC-8 and two at BD-2) (see Table 2-4)	None observed	None observed	Photo station marked with new rebar and red paint.

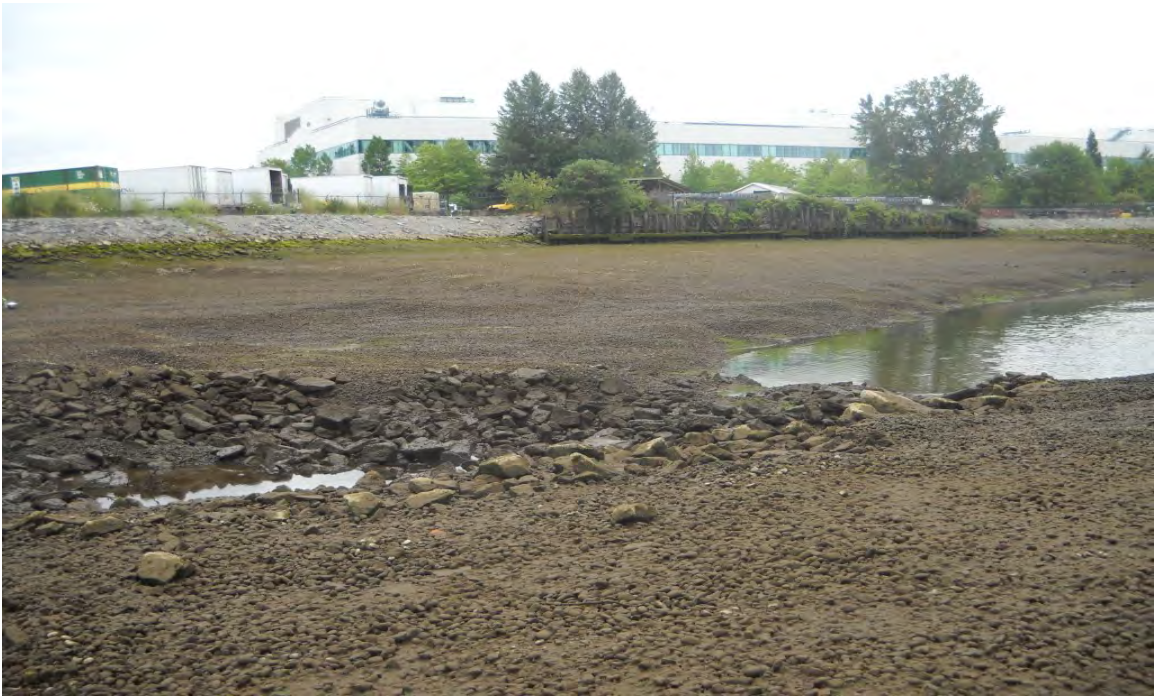
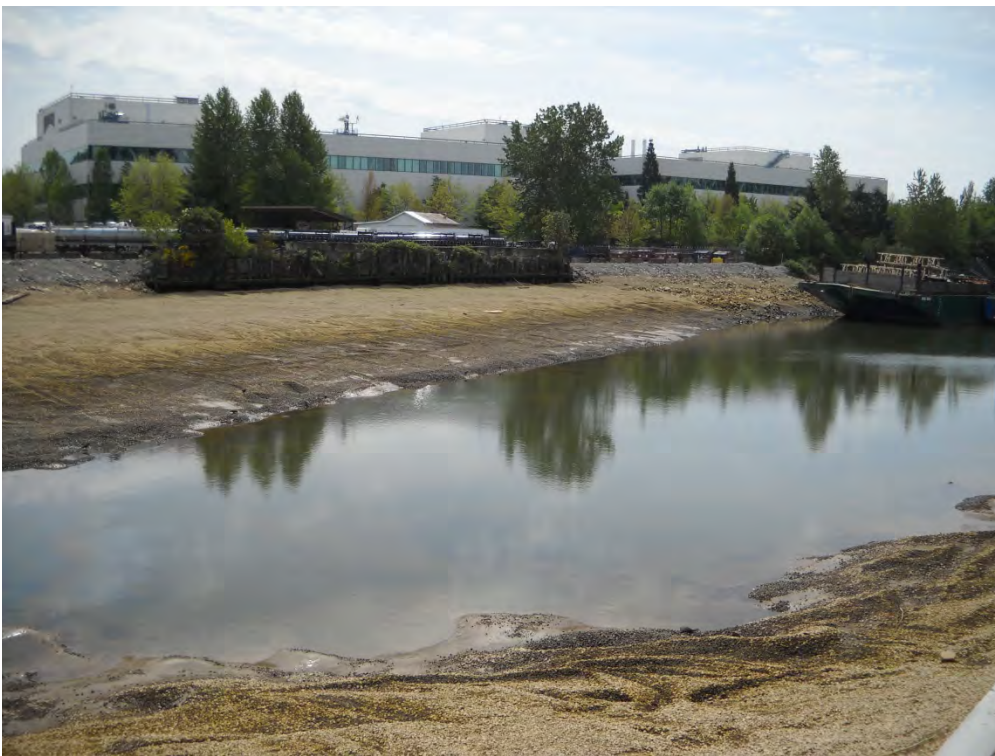
F2\_Southeast Slope and Sediment Cap – Azimuth 160 T\_2013

Southeast Slope and Sediment Cap	F2	7/22/2013	1057	160 T	Gravel, sand, silt/clay	Brown	< 1 cm	Algae coating gravels of cap material	Crows feeding	Good
South Rip Rap Slough	G1	7/22/2013	1038	200 T	Cobble, gravel, sand, silt/clay, organic matter and wood/shell fragments	Brown	< 1cm	Twigs, sticks, sea lettuce and leaves	Flies	Good
North Rip Rap Slough, Sediment Cap, North Slope Cap	G2	7/22/2013	1045	27 T	Cobble, gravel, sand, silt/clay, organic matter and wood/shell fragments	Brown	~ 1 cm	Twigs, sticks, sea lettuce, trace leaf litter	None observed	Good
Northwest Slope Cap, Beach Cap, Sediment Cap	H1	7/22/2013	0933	306 T	Cobble, gravel, and sand	Brown and gray	(not noted)	Feathers, goose droppings	(not noted)	Good
West Sediment Cap	I1	7/22/2013	0920	278 T	Cobble and gravel	Brown	0-1 cm, fines and sand deposits ~3 cm thick in some limited areas on slope	Twigs, fine green algae/moss, trace leaf litter, sticks, bird droppings	Great Blue Heron and crows observed. Heron observed hunting along waterline. Crows pecking at sediment, bird droppings, flies. Some areas of sediment fines show burrow openings	Good

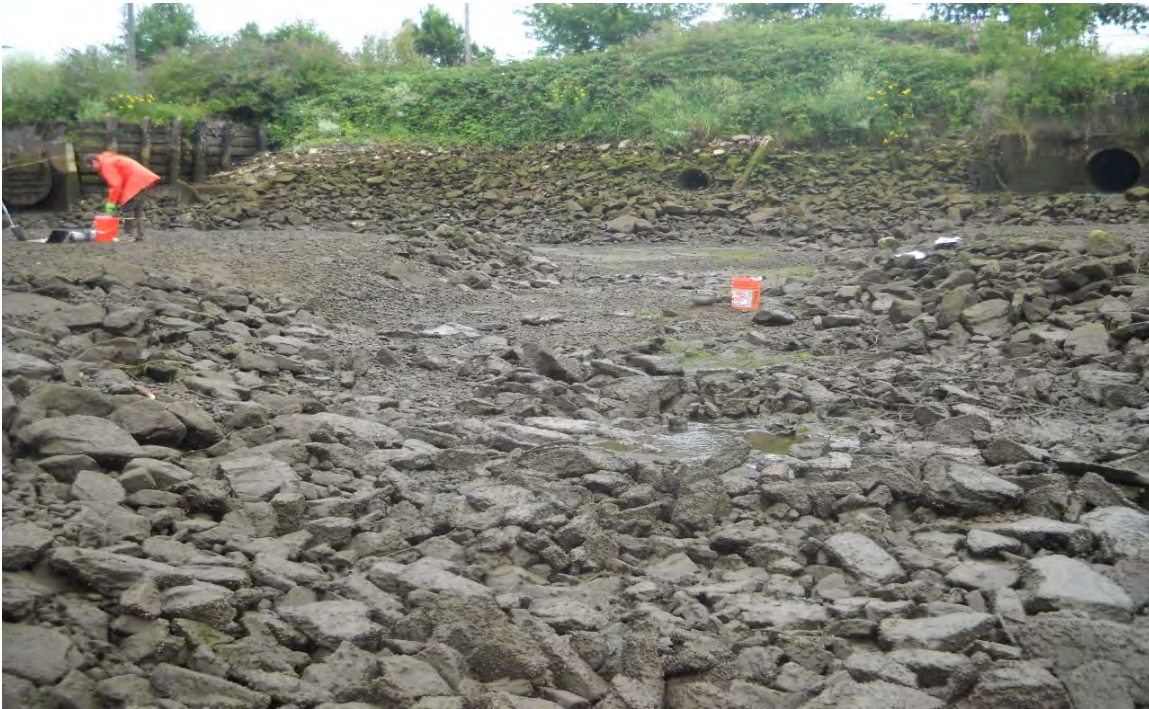
G2\_North Rip Rap Slough, Sediment Cap, and North Slope Cap – Azimuth 27 T\_2013

North Rip Rap Slough, Sediment Cap, North Slope Cap	G2	7/22/2013	1045	27 T	Barnacles on rocks	None observed	Trace plastic debris	Same as above.
Northwest Slope Cap, Beach Cap, Sediment Cap	H1	7/22/2013	0933	306 T	(not noted)	None observed	Minor plastic debris	Photo station marked with new rebar and red paint.
West Sediment Cap	I1	7/22/2013	0920	278 T	Small barnacles on some riprap rocks and gravel	None observed	None observed	Station moved from the upland property to just within the EAA boundary. New location was marked with new rebar and red paint.
Southeast Slope Cap	J1	7/22/2013	1125	130 <sup>b</sup> T	No intertidal fauna observed	None observed	None observed	Station location moved from target to the 8th Avenue Terminals bulkhead for on-foot access; new location marked with new rebar and red paint.

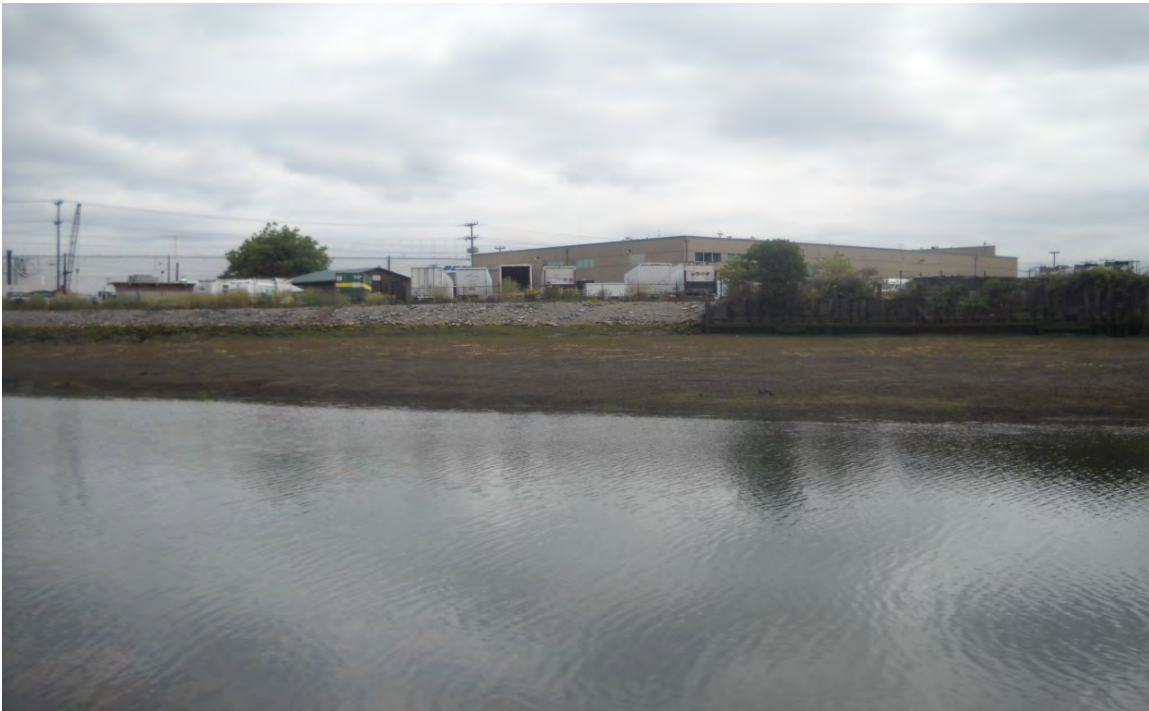
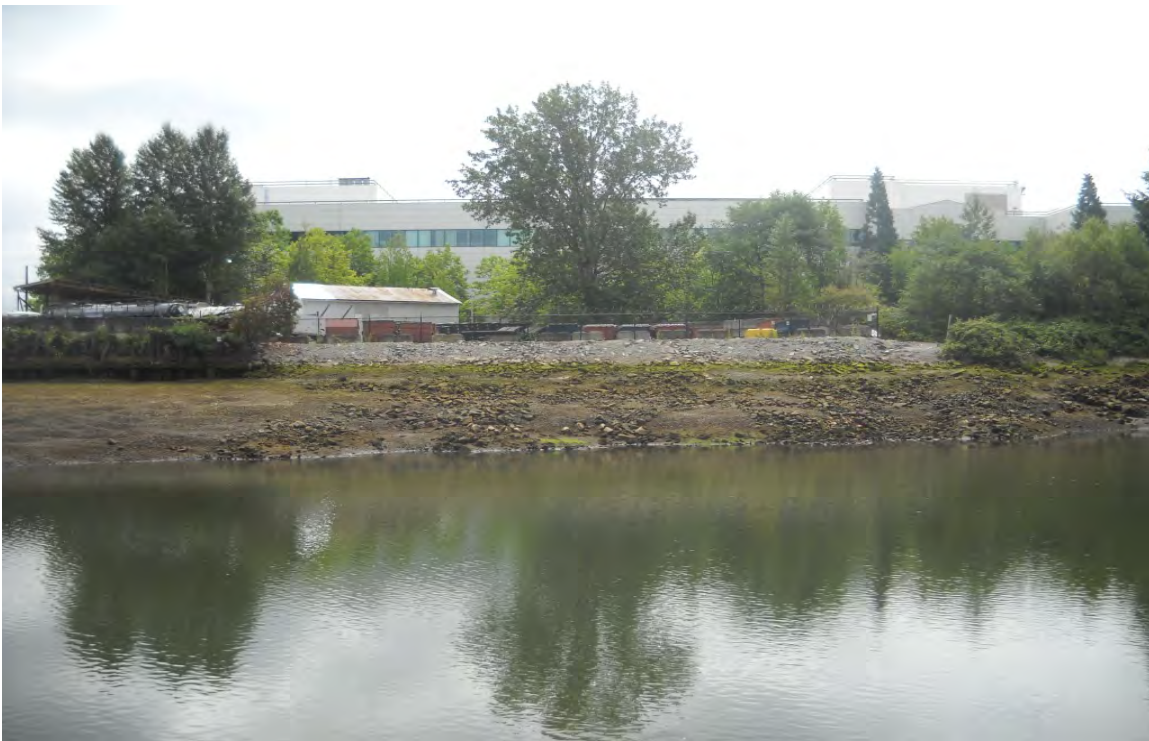
J1\_Southeast Slope Cap – Azimuth 130 T (estimated)\_2013

Southeast Slope Cap	J1	7/22/2013	1125	130 <sup>b</sup> T	Cobble and gravel	Gray	< 1 cm	Algae coats intertidal portion of slope cap	None observed	Good
